4.1 Introduction

4.2 Macs Reef Landfill

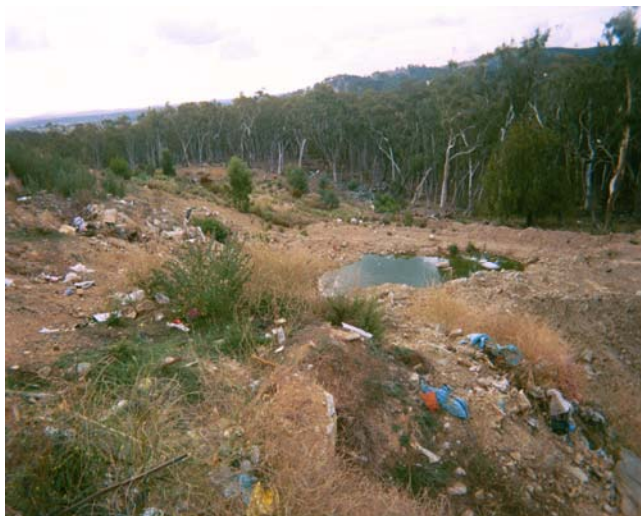
- **Uncovered waste:** Due to a shortage of cover material on the site, waste is kept uncovered for long periods (greater than 2 weeks). This results in several environmental issues including windblown litter, feral animals, odour and increased leachate production. Some complaints have been received from residents to the north (opposite side of Macs Reef road from Landfill) regarding windblown litter.

Photo 1 Windblown litter on slopes of landfill

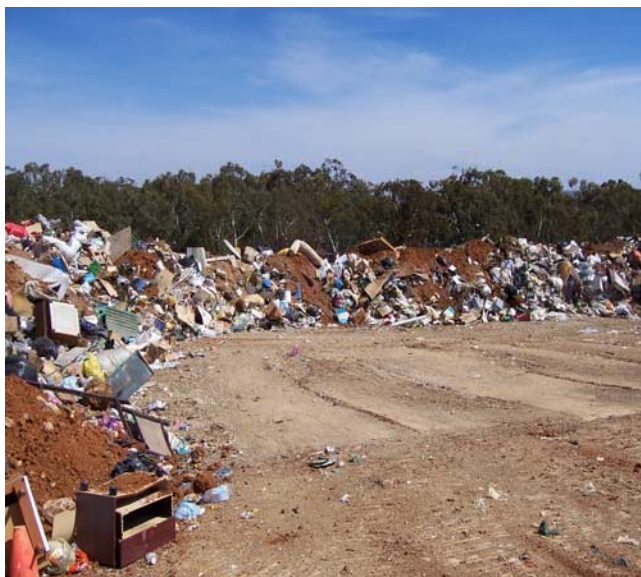
Photo 2 Uncovered Waste

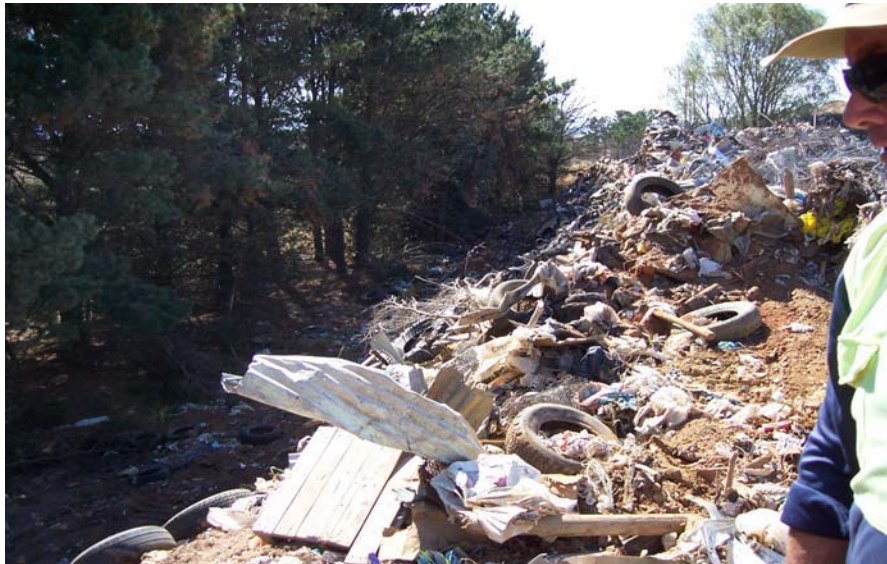
Photo 3 Uncovered batter slope

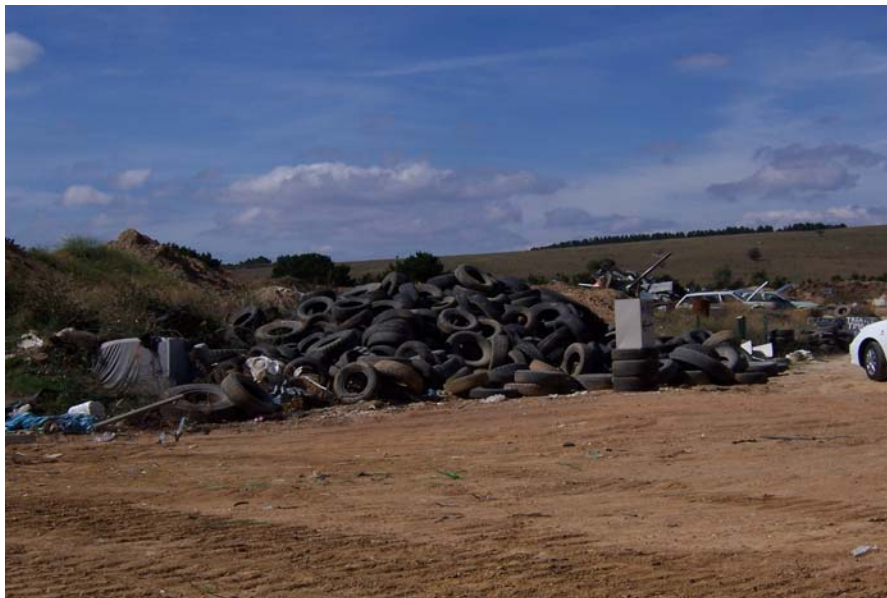
Photo 4 Tyre Stock Pile

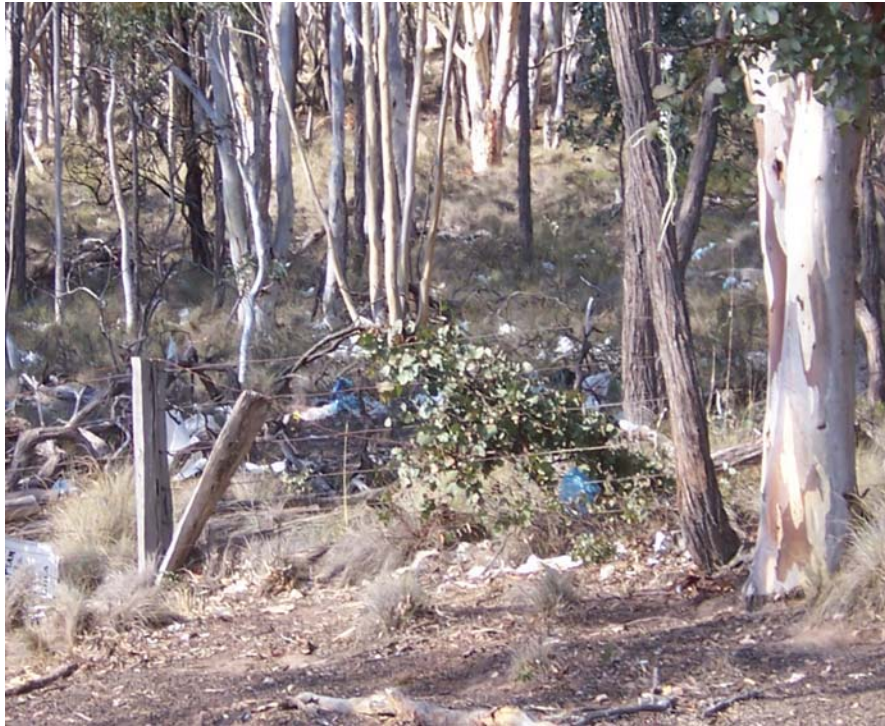
Photo 5 Windblown Rubbish

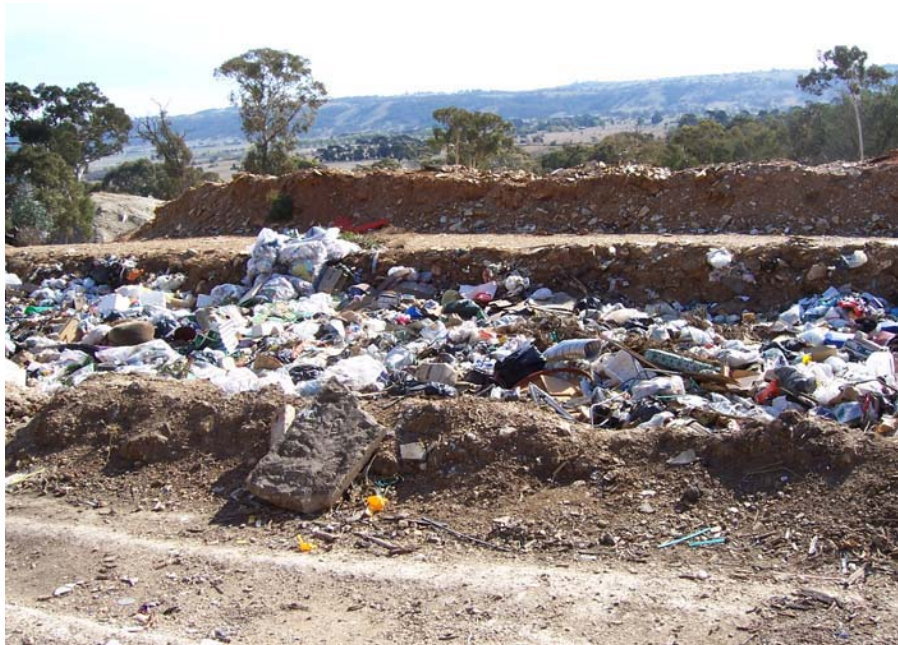
Photo 6 Uncovered Waste Trench

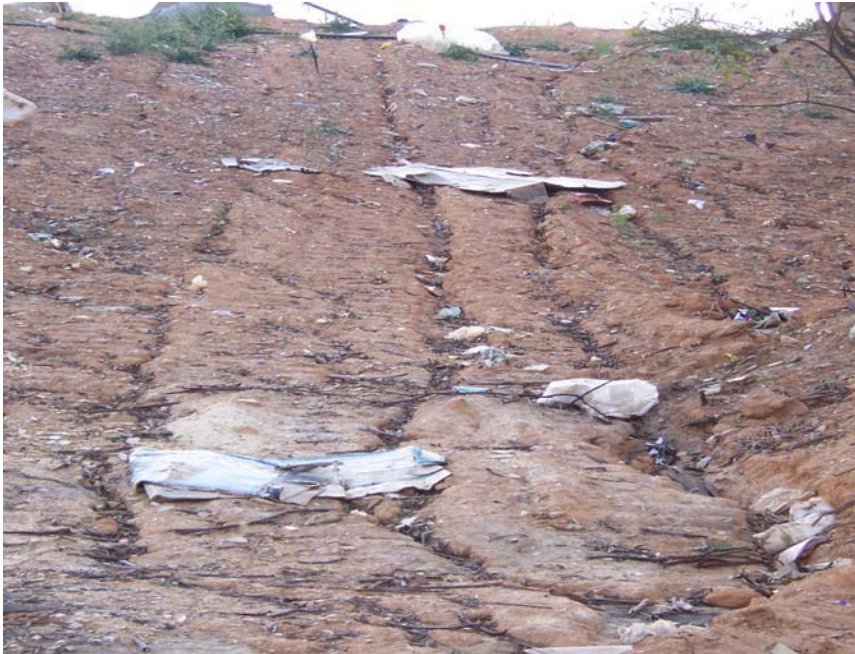
- *Slope Stability:* All batter slopes are only partially covered with suitable capping material and are built at steep gradient in particular on the South East face, which is approximately 40 to 60 metres in height and poses a significant slope stability risk. Significant erosion and litter observed on the batter slopes.

Photo 7: Significant erosion of batter slopes

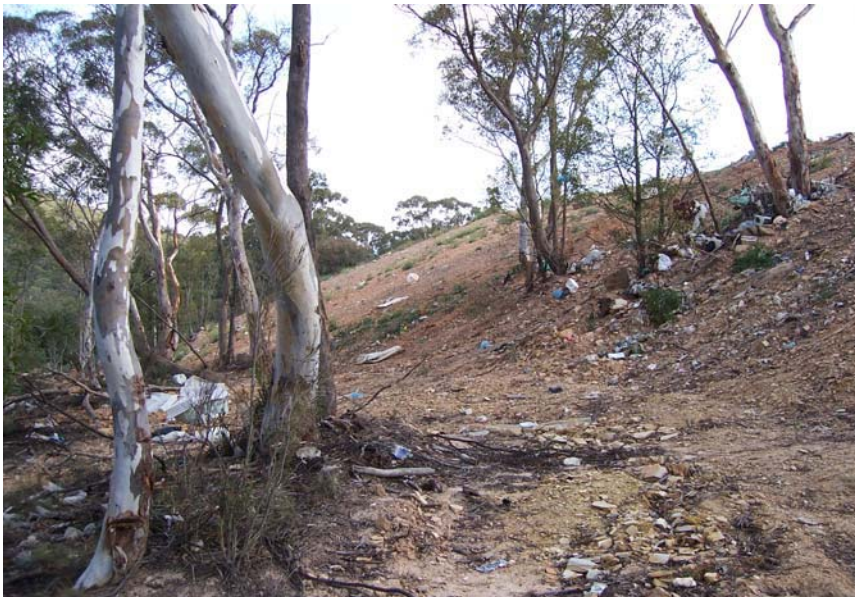
Photo 8: Steep Batter Slopes

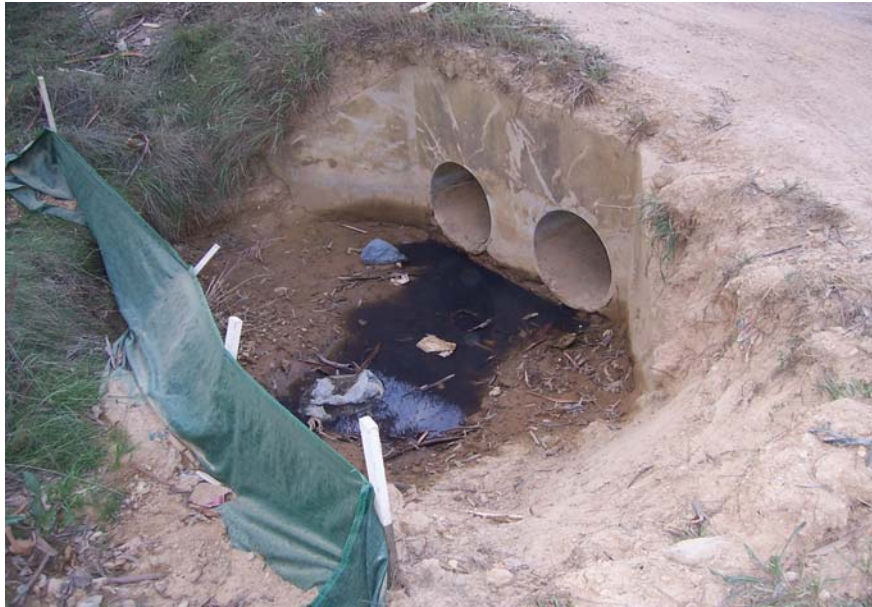
- *Contaminated surface water:* As shown in the photo below there was evidence of contaminated surface water discharge to the stormwater system flowing under the road to adjoining property to North of the site.

Photo 9: Evidence contaminated surface water discharge to stormwater system flowing under road to adjoining property to North of the site.

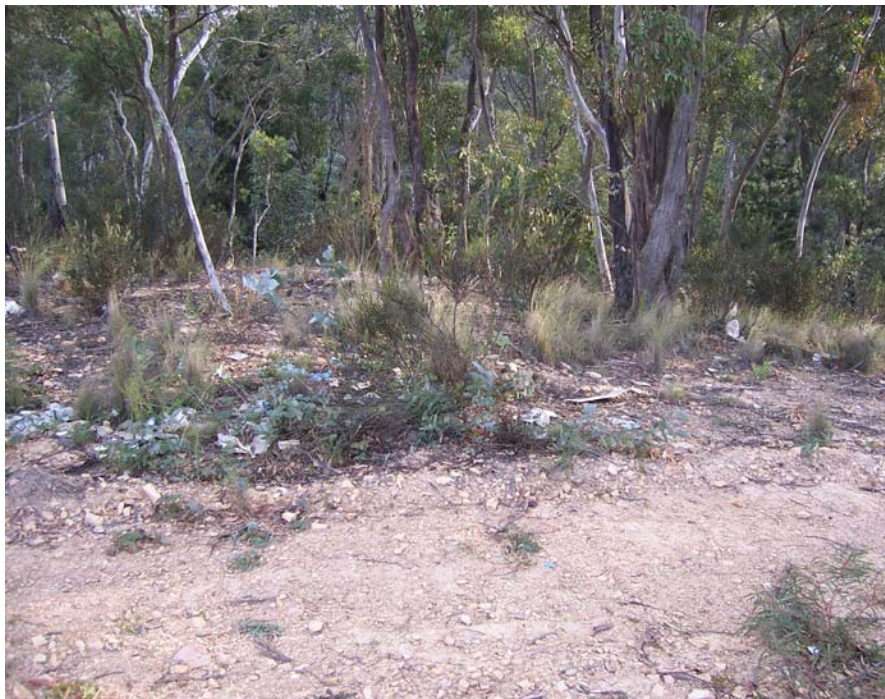
Photo 10: Windblown litter into adjoining properties

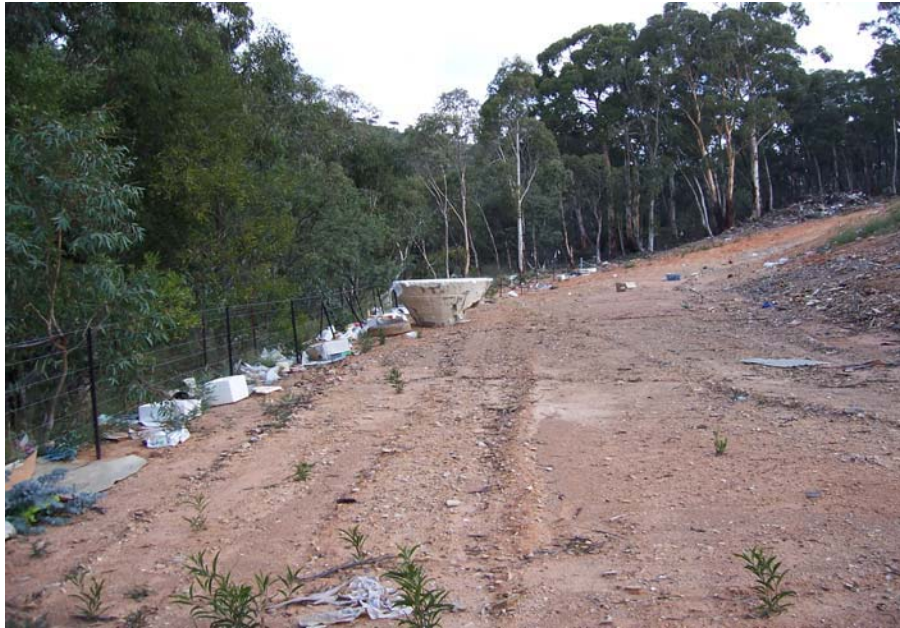
Photo 11: Windblown litter against landfill fence and into adjoining properties

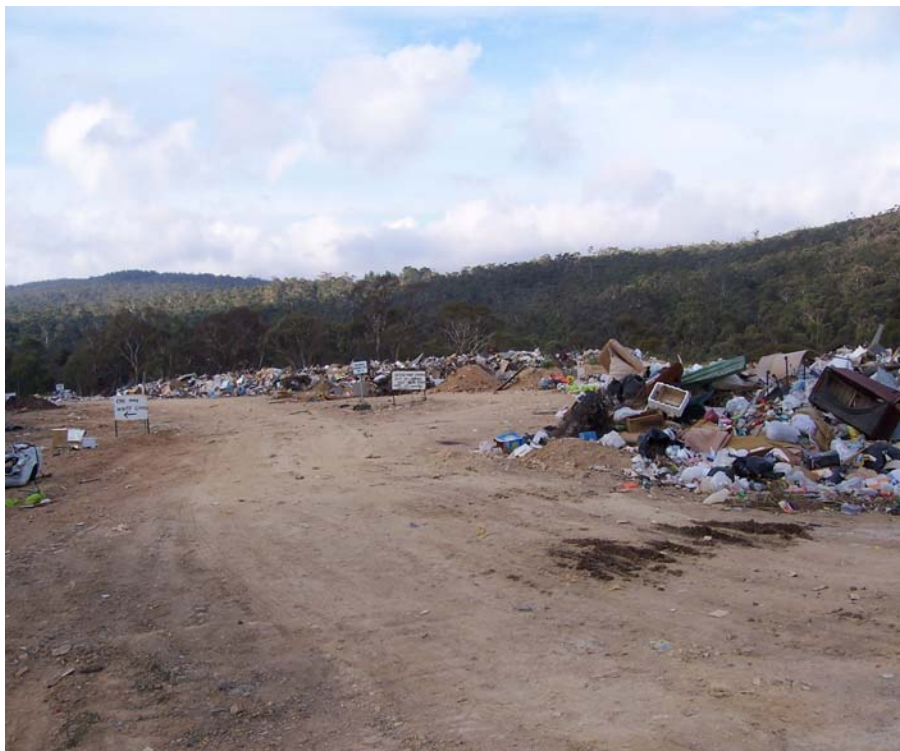
- *Uncovered waste:* As with the other landfills in the Council, due to a shortage of cover material on the site, waste is kept uncovered for long periods (greater than 2 weeks). This result in several environmental issues including windblown litter, feral animals, odour and increased leachate production.

Photo 12: Waste kept uncovered for long periods (greater than 2 weeks) due to unavailability of cover material resulting in windblown litter, feral animals, odour and increased leachate.

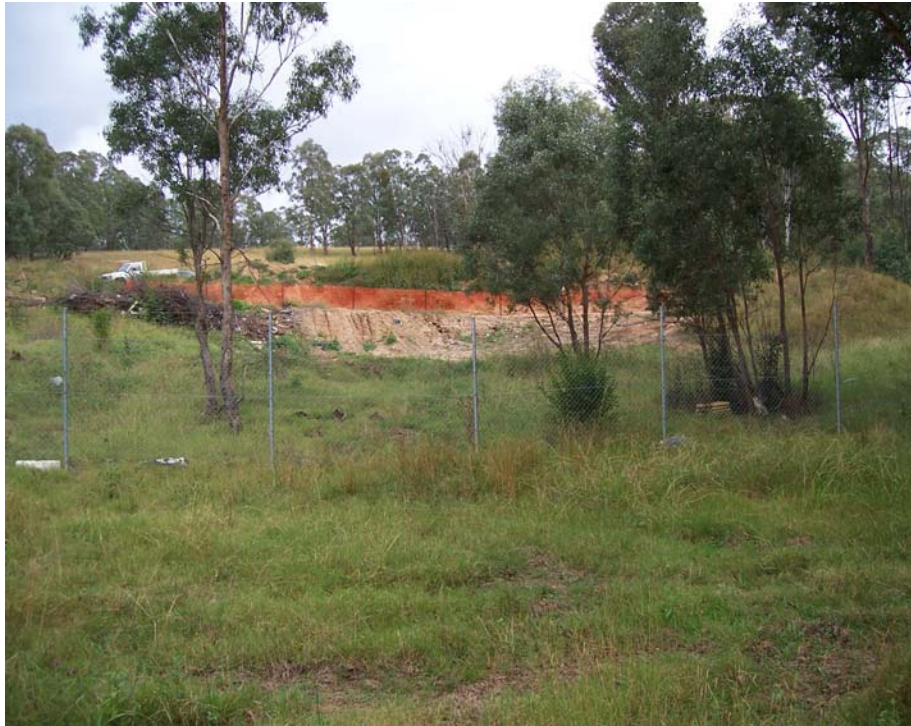
Stormwater management: As the land to the west of the site is steeply graded, there may be an issue with stormwater running onto the site, through the waste, and into the private property located in front of the landfill. Therefore further investigation should be carried out to improve the stormwater management of the site by diverting around the landfill.

Photo 14 View from the base of the landfill, looking towards the west.

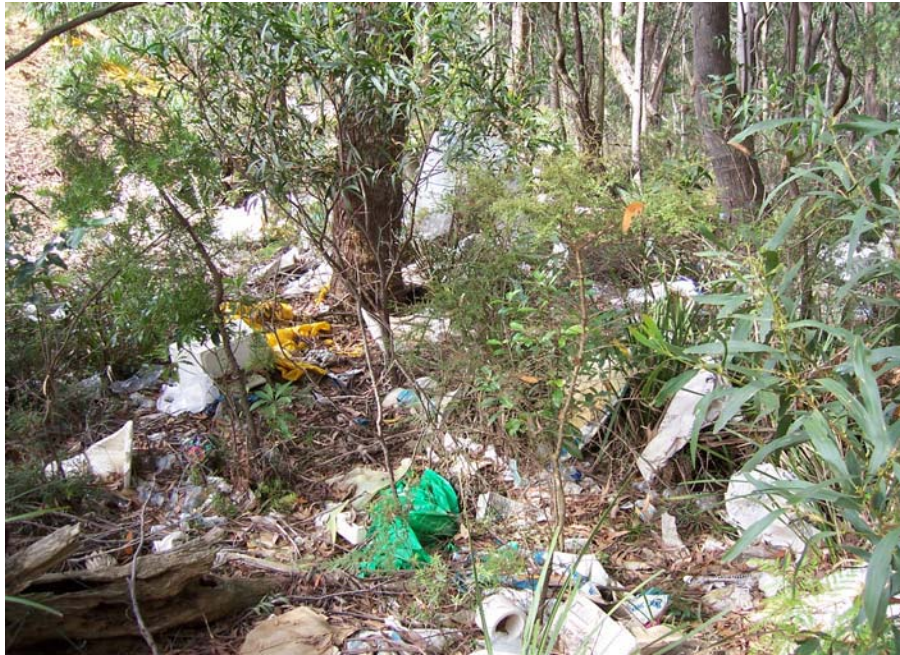
Photo 16 Windblown Litter

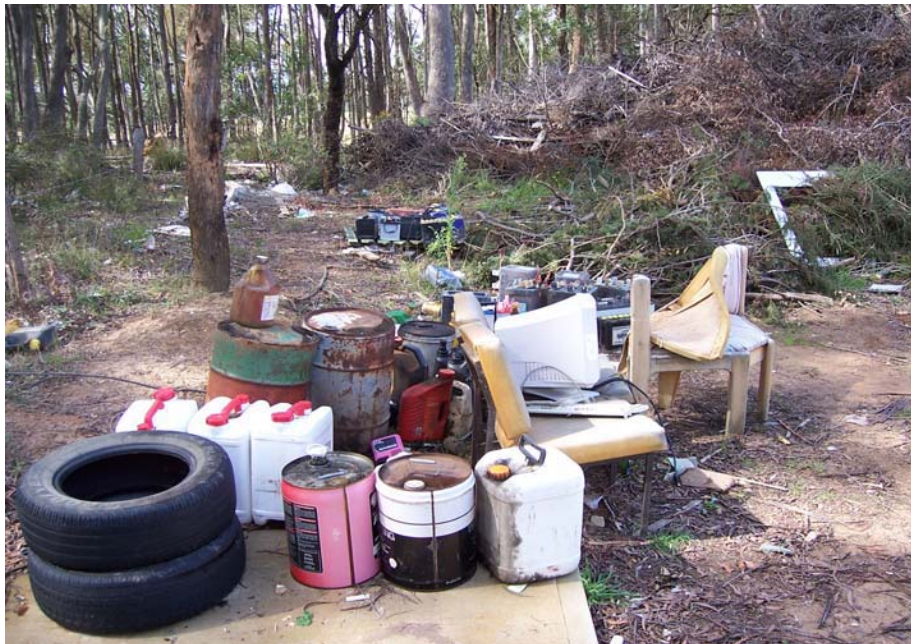
the time of the site visit which contained old white goods and chemical drums. Residents are meant to take these items to the Braidwood landfill.

Photo 17 Mixed Chemical Containers

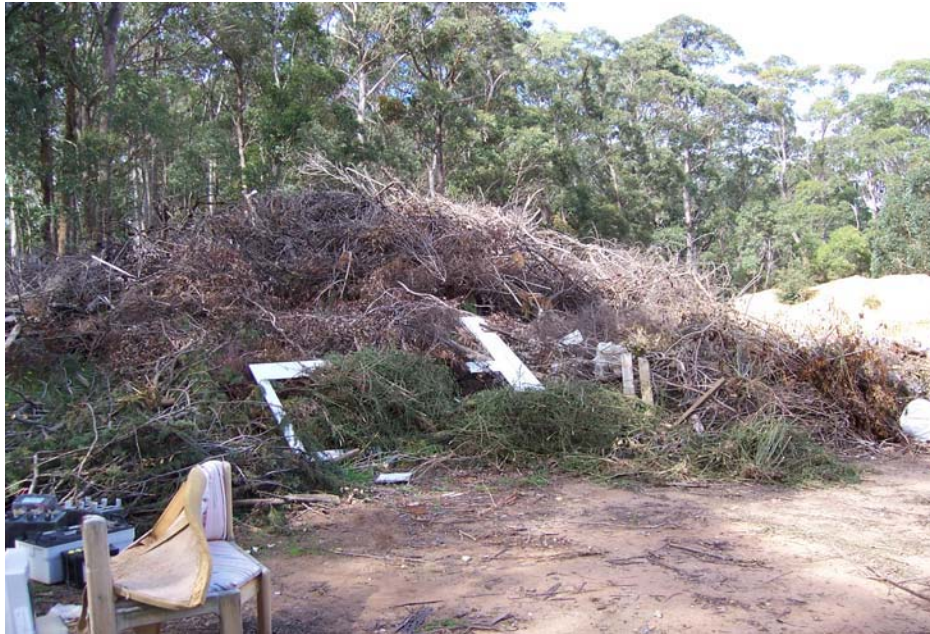
Photo 18 Contamination of greenwaste stockpile with other materials such as painted timbers, metals and general waste

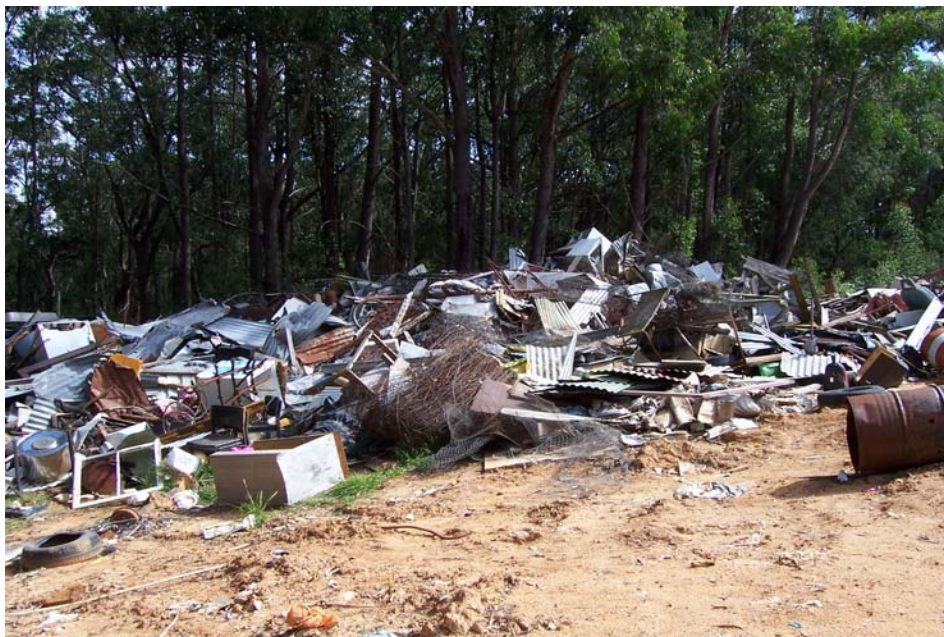
Photo 19 Scrap metal stockpile

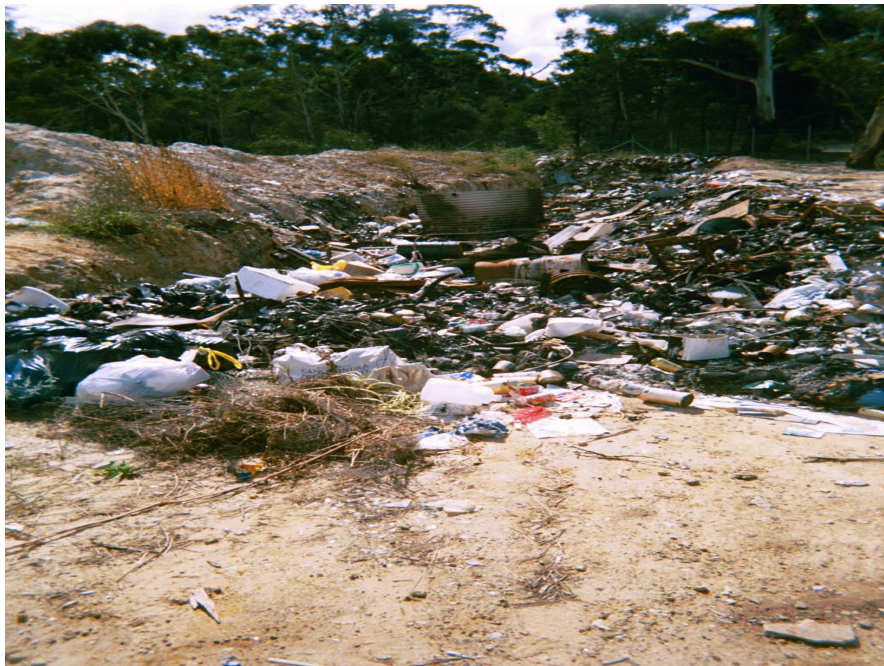
Photo 21 Uncovered Waste in Trench

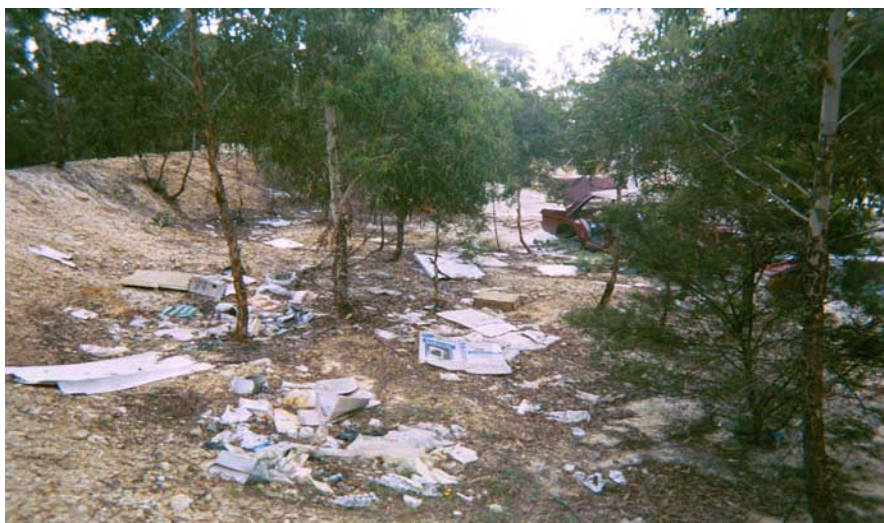
Photo 22 Windblown litter on site (It is noted that no off site wind blow litter observed surrounding site)
