4.1 Introduction

4.2 Macs Reef Landfill

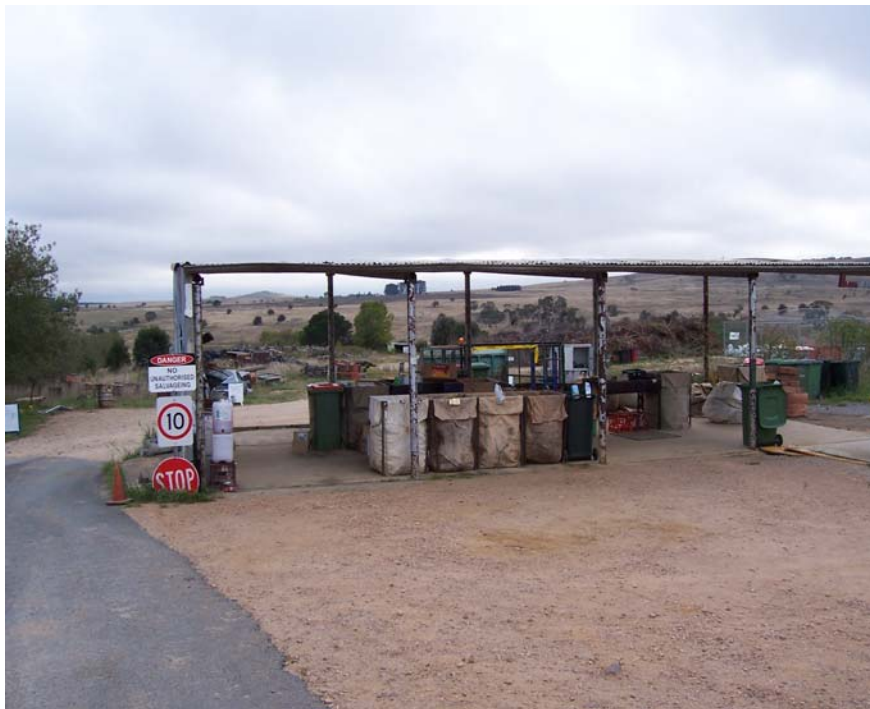
A well-managed, covered recycling centre is provided on site, which collects clear plastic, aluminium, and glass containers, which are all collected by Smorgans for recycling. Paper and cardboard are collected by a contractor and taken to Visy in Canberra for recycling. Other resource recovery facilities provided on site include collection points for clean chemical drums (collected by Drummaster), cooking oil, white goods and scrap metal including old car bodies

Photo 13: Braid wood landfill Recycling Centre

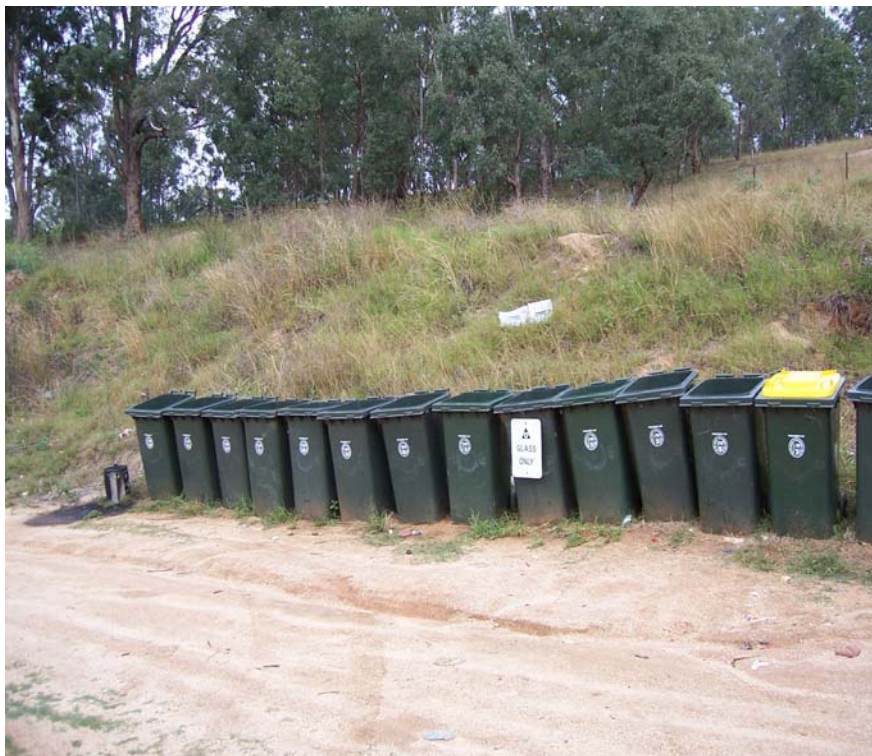
Photo 15 Existing Resource Recovery Facilities

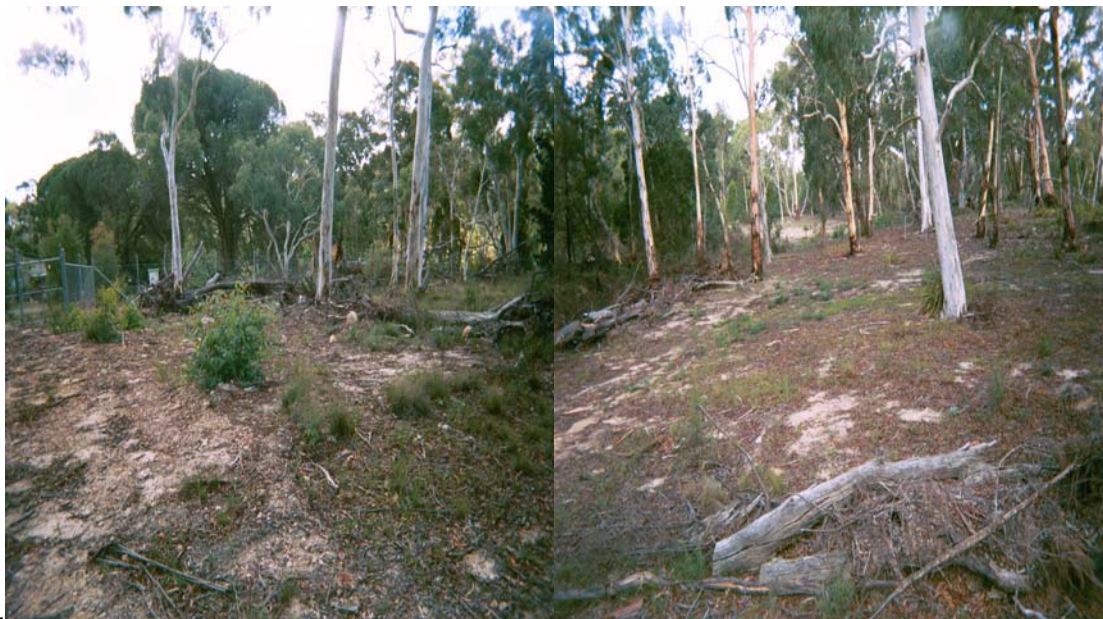
Following completion of the existing trench there is room for one or two further trenches to east. Also the western section of the landfill site is completely unfilled, and based on the current filling rate there is over 20 to 30 years life remaining in the landfill site.

Photo 20 Site for future expansion on western side of site

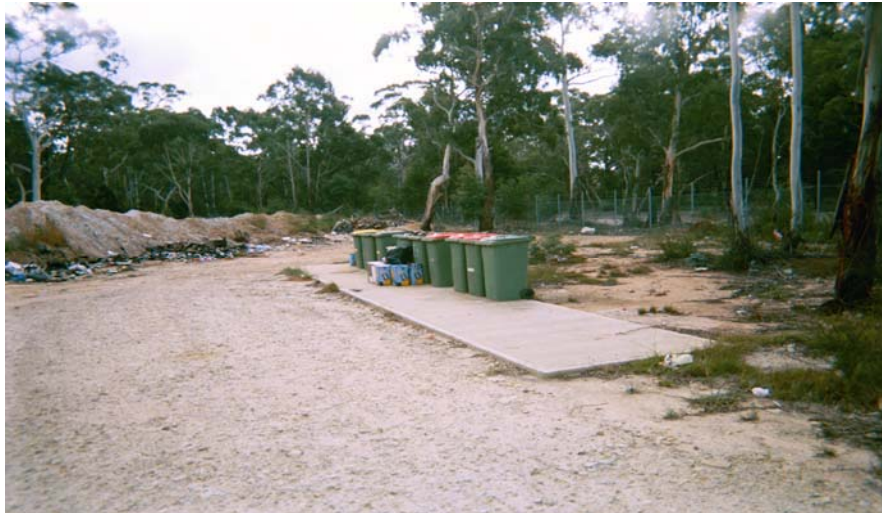
Photo 23 Existing recycling MGBs
